# STRENGTHENING OF OXIDATION RESISTANT MATERIALS FOR GAS TURBINE APPLICATIONS

By H. P. Kirchner

Ceramic Finishing Company  
Box 498  
State College, Pennsylvania 16801

NASA Lewis Research Center  
Contract NAS3-16788

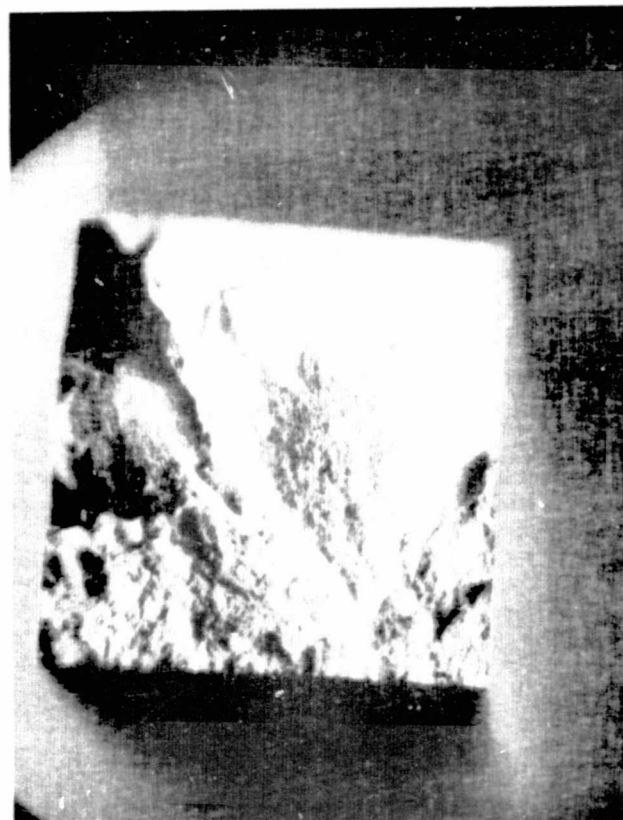
(a) Weak fracture in a specimen containing a thermal shock crack.

(b) Strong fracture in a specimen strengthened by quenching.

Figure 3 Comparison of fracture surfaces of quenched silicon carbide specimens with and without thermal shock cracks (IOX) .
